THE BLACK HILLS (South Dakota) FLOOD OF JUNE 1972: IMPACTS AND IMPLICATIONS

by Howard K. Orr

USDA Forest Service
General Technical Report RM-2

March 1973

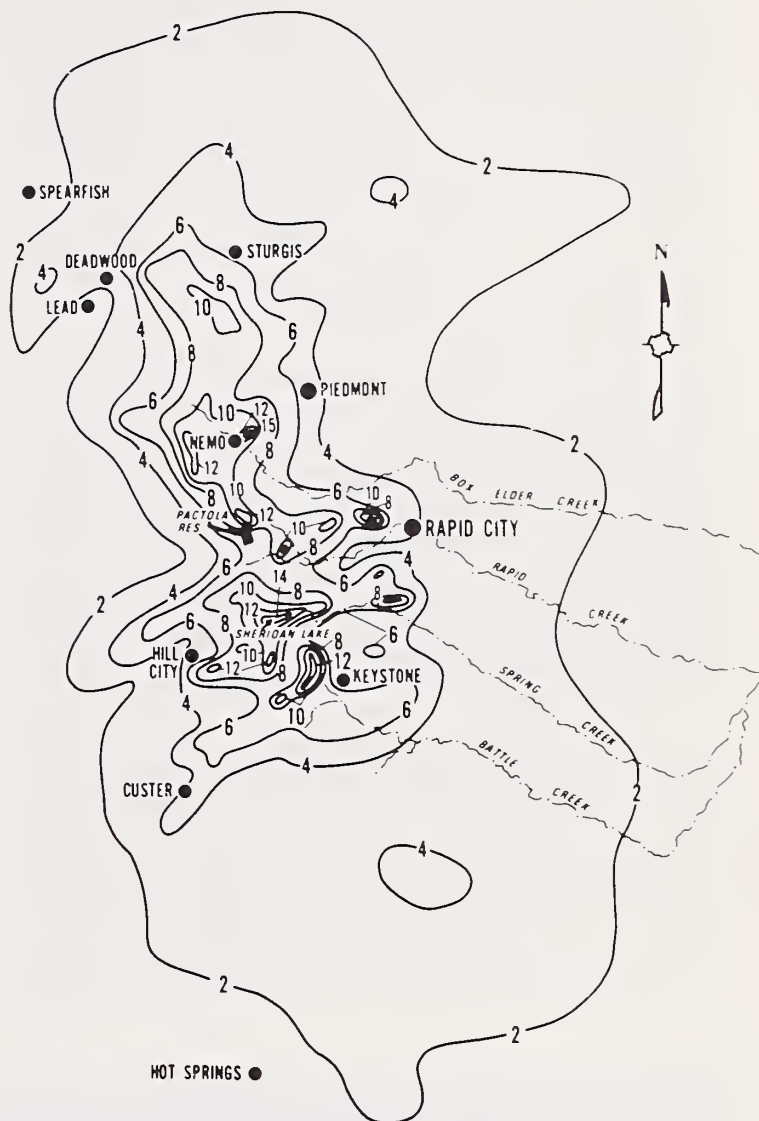
Figure 1.--Total rainfall during evening of June 9 into morning of June 10, 1972 (U. S. Department of Commerce 1972).

The storm was concentrated in an area about 40 miles long by 20 miles wide. The area includes downstream portions of nearly all the watersheds draining east out of the Black Hills from Bear Butte Creek on the north to Iron Creek (tributary to Battle Creek) on the south (fig. 1).

According to recording gages on the Sturgis Experimental Watersheds (in the northern part of storm area, fig. 1), precipitation began at about 1450 (m.s.t.), and gradually built up to a maximum intensity of nearly 6 inches per hour about 1630. Rain continued steadily but at gradually declining intensity until between 0200 and 0230 on June 10.

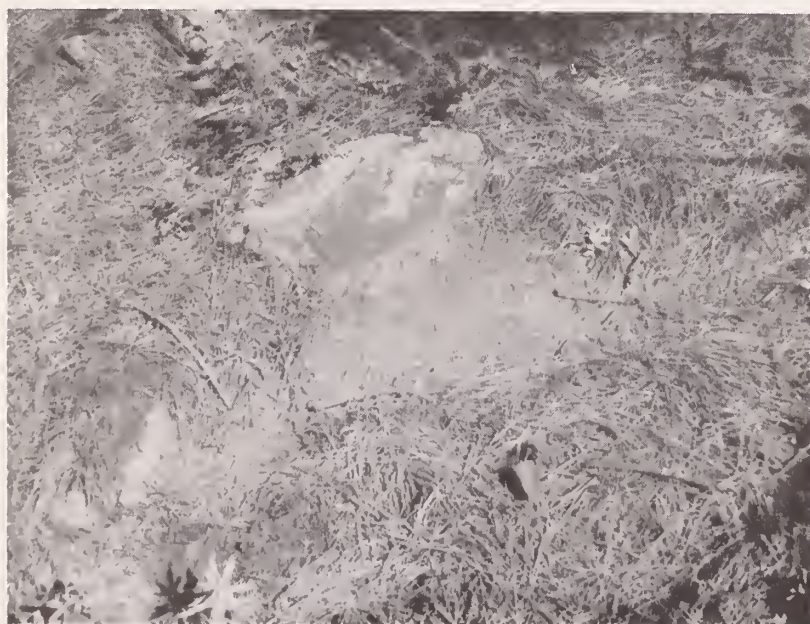
Figure 2.--Water apparently flowed through this thick forest floor without disturbance until it was diverted or ponded by stones. When this happened, the litter floated and moved downslope (right to left), leaving a small spot of bare mineral soil. Many such spots could be seen on some slopes.

In all of the most heavily flooded watersheds examined, there was consistent evidence of surface runoff from slope areas even where there were no clearly visible drainage patterns, and further upslope than in the case of more ordinary storms. The consistency of this kind of evidence, irrespective of site, is a key factor in analyzing the production of the flood flow. Surface runoff occurred from all types of areas, including dense forest and well-grassed slopes. In other words, classification in "good" hydrologic condition did not in this case preclude the production of excessive surface runoff. Surface runoff is here differentiated from overland flow in the sense that surface runoff was evident in shallow depressions of microtopography not ordinarily observed, but there was little evidence of sheet movement of water that resulted in sheet movement of soil or its protective cover of litter and humus. This is a generalization that applied across forest types and densities, other vegetation types, slopes, topography, parent materials, geology, and soils. Thick forest floor, where present, apparently acted as an efficient water conveyance system, but without displacement except where water was diverted or concentrated by stones, roots, or other obstacles (fig. 2). The storm and runoff produced were obviously of a magnitude that plays a major role in shaping topography as we see it today.

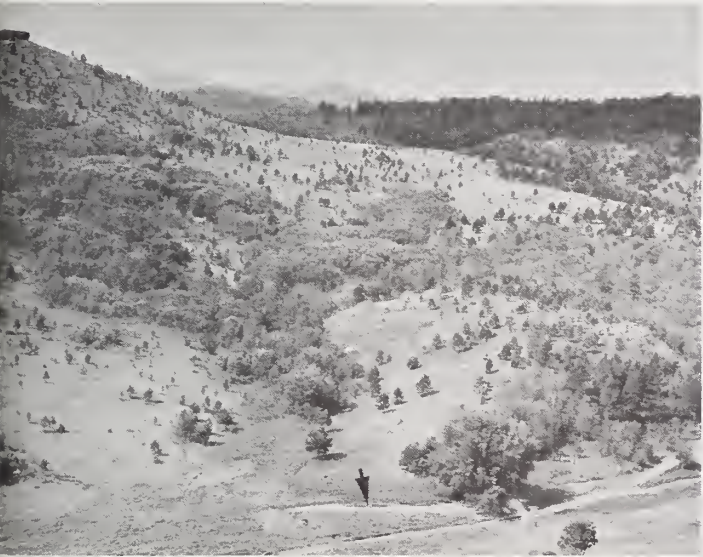
Figure 4.--Looking back southwest from high on the slope in figure 3. One of the main tributary channels of Wild Irishman shows in the lower portion of the photo, and flood-deposited material is visible (arrow), together with an old road.

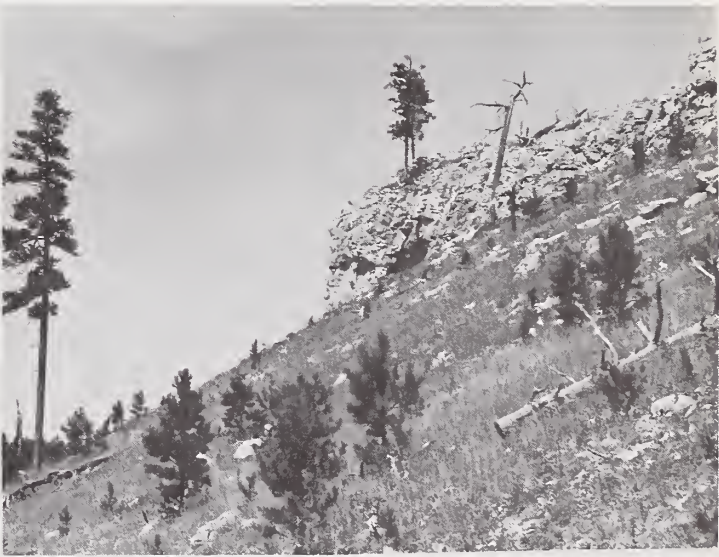
Figure 6.--Looking mostly west (left) across the left portion of the slope in figure 3. Vegetation is a well-established mixture of grasses and forbs. Soils are stable for the most part.

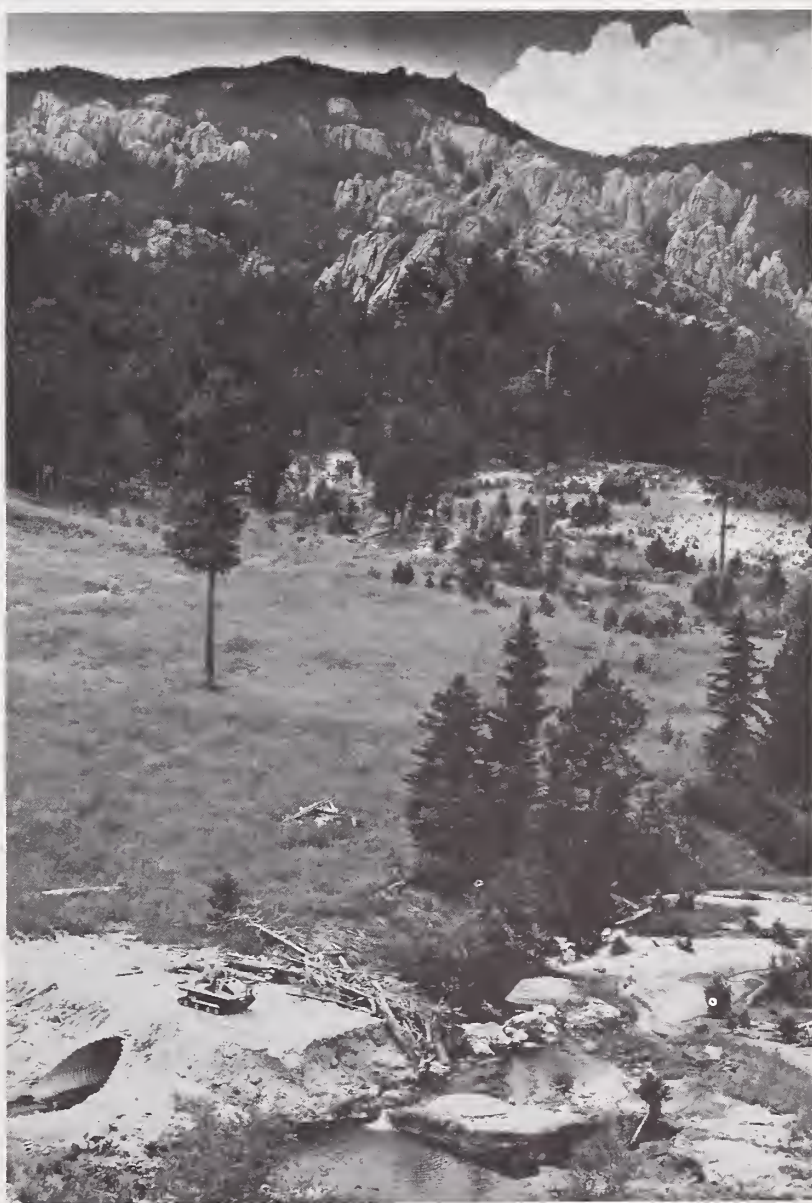
Figure 9.--Channels eroded severely, even in areas that have received little use in many years. Shown here is Grizzly Bear Creek, draining out of the Pine Creek Natural Area in the Harney Range. Parent rock is granite, which here weathers to a coarse-textured shallow soil with low storage capacity.

Another watershed of particular interest is Grizzly Bear Creek, which drains from a research natural area on the Precambrian granite of the Harney Range (fig. 9). This area has had little disturbance of any kind in many years. Yet the stream flooded inside as well as outside the boundary of the Natural Area, enough to drasti-

cally erode and alter some channel sections. Litter piles and associated upslope bare spots again attested to the production of significant surface runoff from a microtopography that would not ordinarily be noticed. There is evidence, however, that watersheds in this general area have low storage capacity due to coarse-textured parent material, and an obvious history of flooding, even during much lesser storms.

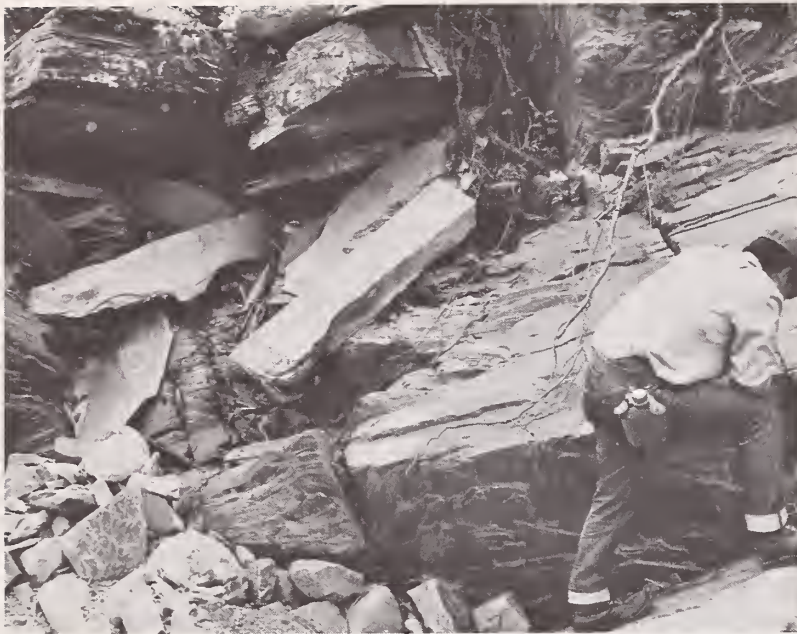
Figure 10.--Characteristic metamorphic parent material in part of storm area that received some of the heaviest rainfall. Flooding from a drainage no more than 1 mile long caused this channel damage, which was on the outside of a turn.

A large proportion of the most heavily flooded watersheds was in areas of metamorphic parent material of the general type shown in figure 10. Material of this type characteristically breaks down to loamy soils, often quite stony. The kind of erosion shown in figure 11 is typical of what happened to cut slopes in residual soil. Fines were washed out, leaving stones protruding. Slumping of steep road cuts was not uncommon in this kind of situation.

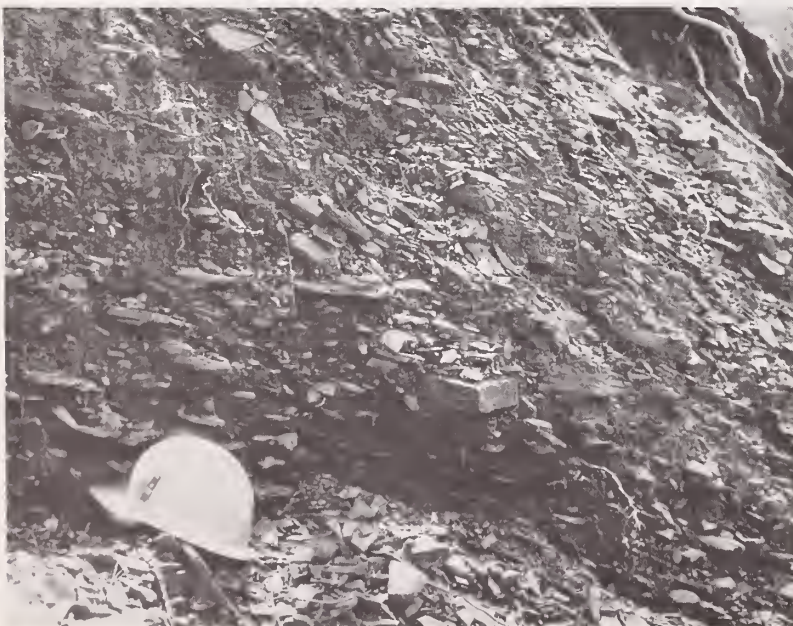
Figure 11.--An old road cut through residual soil, metamorphic parent material, after the June 9 flood. Fines were washed out. Platy rock was then either left protruding or it fell out and into an accumulation at the base of the slope. This sort of thing did not happen on newer back-sloped roads.

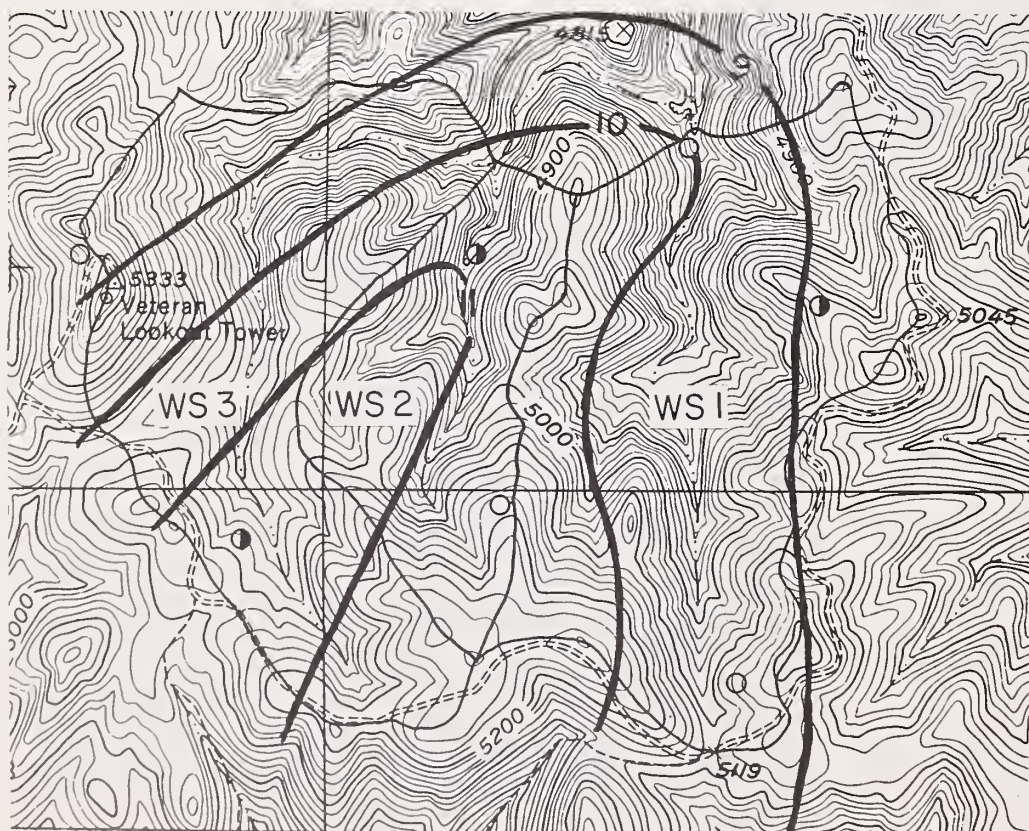
Figure 15.--Isohyetal map of the June 9, 1972 flood-producing storm on the Sturgis Experimental Watersheds:

Left, watershed 3;
Center, watershed 2;
Right (east) watershed 1.

The watersheds behaved about as would be expected. WS2 apparently received most rainfall (fig. 15), and produced the highest unit area peak runoff (table 4). WS3 received second

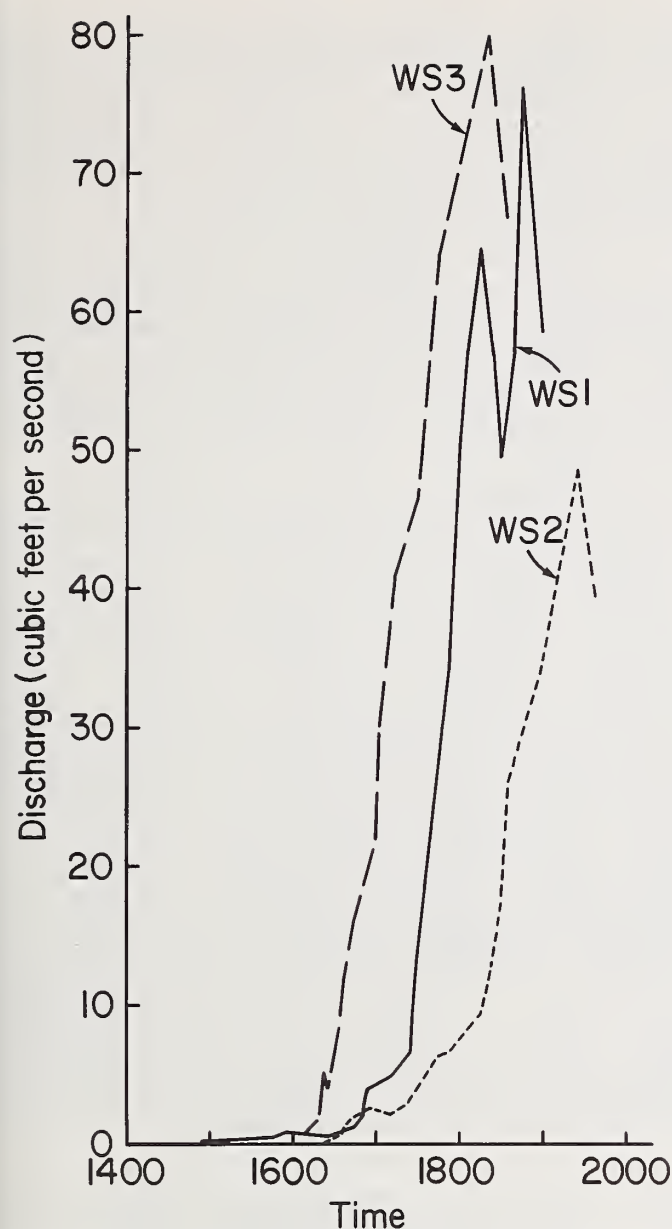
Figure 16.--June 9, 1972 storm flow hydrographs to about time of peaks. Debris deposits caused loss of the remainder of the hydrographs.

Maximum peaks (fig. 16) were less clearly recorded in WS1 and WS2 than in WS3. Nevertheless the peaks, as well as amounts already presented, are reasonable. WS1 hydrograph did not start maximum acceleration until about 1 hour after WS3, which is not surprising considering the fact that by the time of peak in WS3, 2 inches more rain had fallen there than in WS1.

Reasons for the two recorded peaks at WS1 are not clearly apparent. It may be that landslides (several occurred in WS1 and WS2, fig. 17) temporarily blocked flow. The debris dams then washed out, probably releasing enough surge of water to cause another peak at the gaging station. Several such slides may also have been one reason why the hydrograph in WS2 lagged behind both WS1 and WS3, particularly if the slides occurred at about the same time. Response times were opposite what might have been expected considering the fact that, in calculating design discharges, the concentration times were 12.6, 9.0, and 16.2 minutes for WS1, WS2, and WS3, respectively.
